M1 Winter Tank Test
(Traction Devices)

F I N A L R E P O R T

R. L. Smith
Keweenaw Research Center
Michigan Technological University
Houghton, Michigan 49931

October 1982

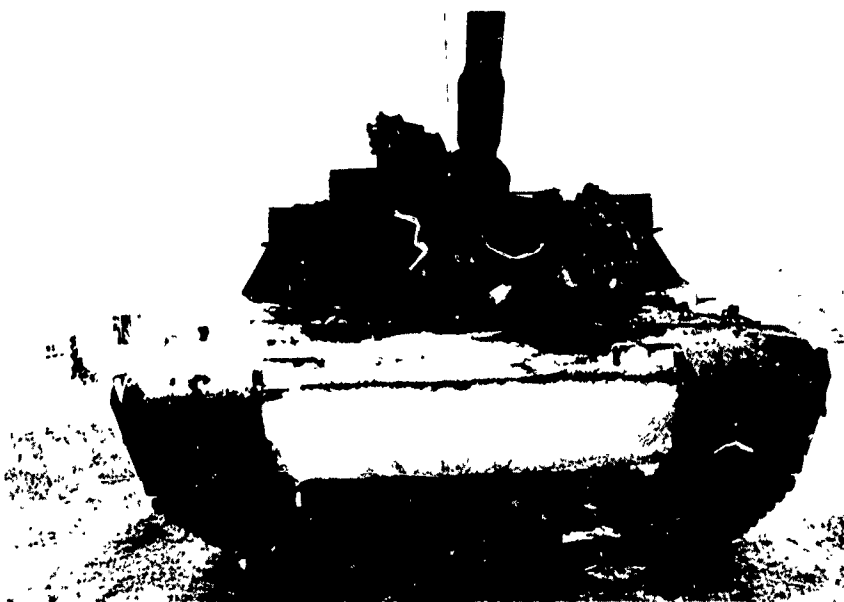
Figure 12. Snow on Front of Hull

It should be noted that during deep snow operation, the vehicle would nose-dive into the snow. With the downward slope of the hull, the front of the vehicle would act like a snow scoop. This action results in snow build-up in the driver area where it can be a potential safety hazard.

At higher speed, snow build-up becomes an even greater problem because the wiper cannot keep up with snow build-up. This requires operation with the driver's hatch open, which allows snow to enter the driver's compartment. Figures 12, 13 and 14 show examples of one such instance. Most of the snow was removed from the driver's compartment before the photographs were taken.
